Manhole Inspection Summary

Manhole # S39AA_035MH

Location Address: **wilmomot ct**

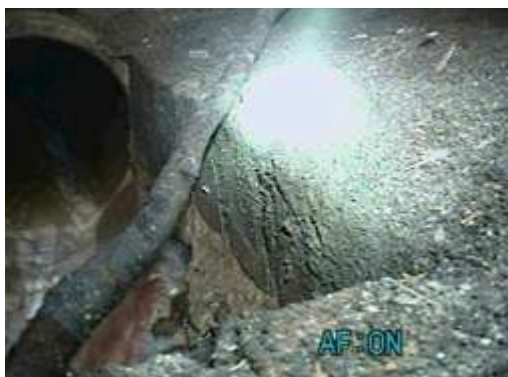
Miscellaneous

bench debris

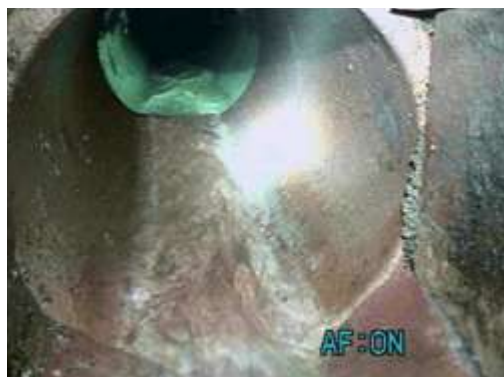
Miscellaneous

inside of 12 pipe changes from clay to PVC

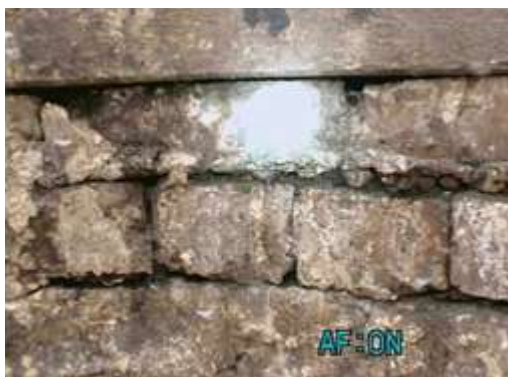
Defect 2

Condition: ☐ Sound ☐ Cracked ☐ Root Intrusion ☒ **Loose Brick** ☒ **Deteriorated**

chimney loose bricks, deteriorated

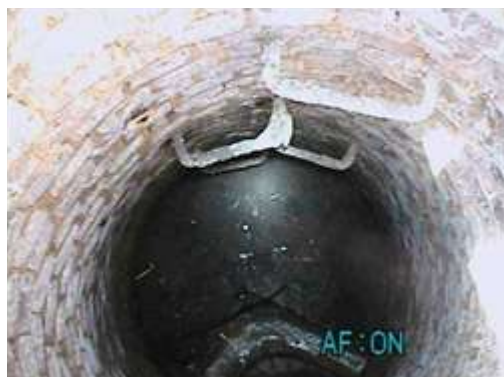
Defect 1

Steps Count: **4** Missing: **0** ☒ **Corroded**

steps

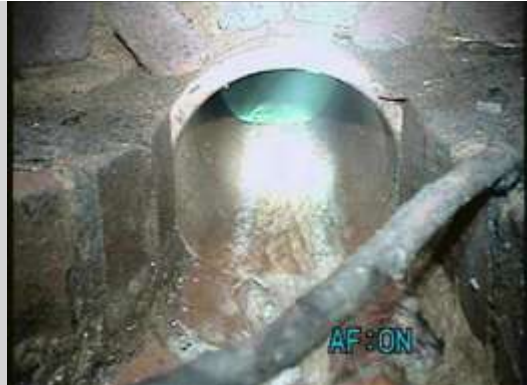
12 O'Clock Outflow

8 in. Circular Gravity Sewer
Pipe Out @ 12 O'Clock

Pipe Material: Clay ☐ Pipe Lined

Invert Depth: 9.54 (ft.) Flow Characteristics: Fast

Deposits: ☒ None ☐ Mud ☐ Sludge ☐ Debris ☐ Grease

Infiltration: None Pipe Seal Cond: Unknown

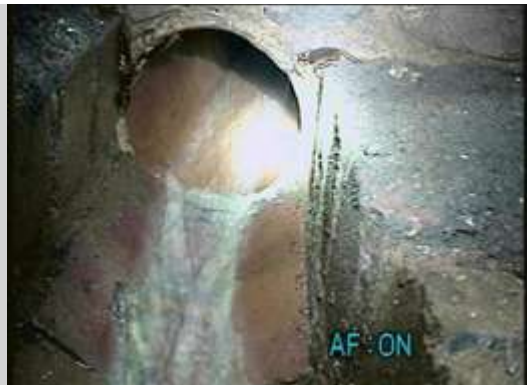
9 O'Clock Inflow

8 in. Circular Gravity Sewer
Pipe In @ 9 O'Clock

Pipe Material: Clay ☐ Pipe Lined

Invert Depth: 9.41 (ft.) Flow Characteristics: Fast

Deposits: ☒ None ☐ Mud ☐ Sludge ☐ Debris ☐ Grease

Infiltration: None Pipe Seal Cond: Unknown
